Inspection Report
By
Certified Home
Inspection
www.wnychi.com

55 Lakeview Street
Buffalo
New York, 14000

General Information

Date of Inspection: **July 4, 2015**

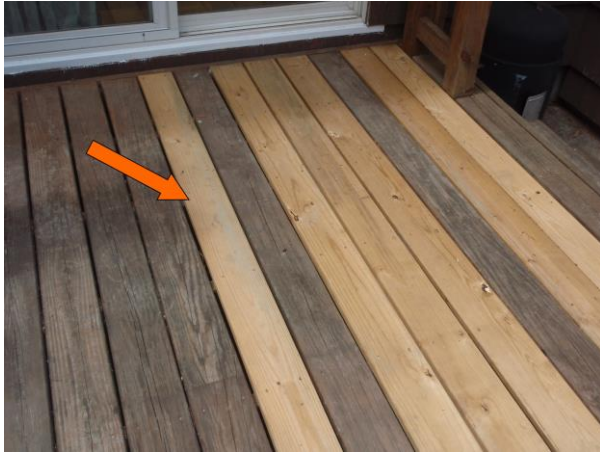
</div> <p><i>Comments: The deck attached to the rear of this building is of wood. Areas of this deck show no sign of paint or stain. Untreated wood in time will rot. Staining the unfinished areas will help prevent rot of the wood and extend the life of this deck. It will also improve the appearance of this deck.</i></p>	<input checked="" type="checkbox"/>		<input checked="" type="checkbox"/>	
<p>3. Guard Rails/ Hand Rails <input checked="" type="checkbox"/> Present <input checked="" type="checkbox"/> Functional</p>	<input checked="" type="checkbox"/>

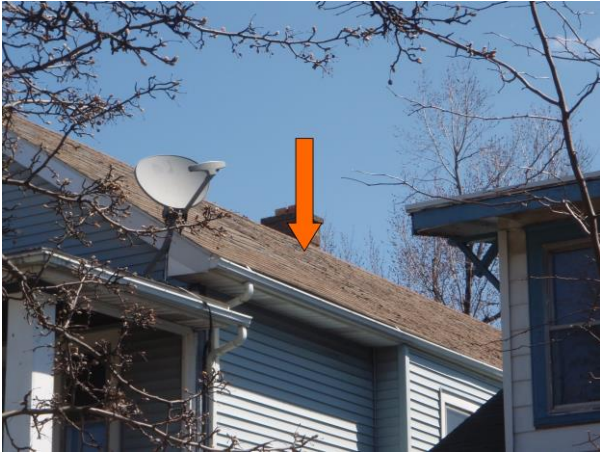
<p><i>Comments: Notice the shingles pictured above are cupping. Loss of the granular covering is apparent. It is clear that this material is beyond its expected life. Replacement is needed.</i></p>			✓		
<p>4. Roof Drainage System</p> <p>✓ Aluminum ___ Plastic ___ Yankee</p>	✓				
<p>5. Downspouts, Elbows, and Point of Discharge</p>	✓

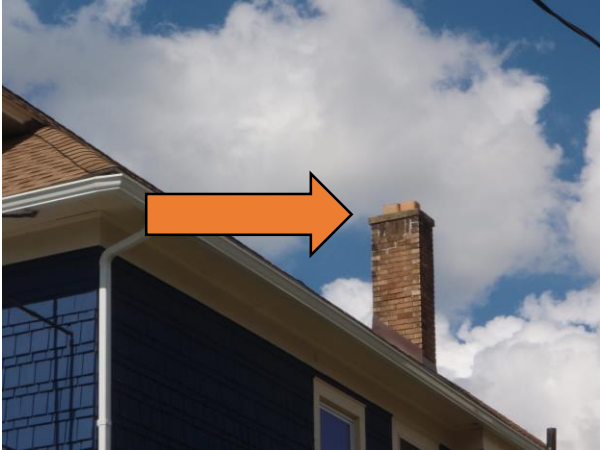
<i>Systems and Components</i>		<i>S</i>	<i>M</i>	<i>P</i>	<i>U</i>
<p>3. Chimney Cap</p> <div style="text-align: center;">

</div> <p><i>Comments: This photograph shows the chimney atop the roof. Note that the flue pictured here is missing its cap. This will allow moisture and debris to enter and possibly damage the homes heating system. It is recommended to install a cap over this flue to prevent moisture or debris from entering.</i></p>			✓		
<p>4. Chimney Flashing Utilized</p> <p><i>Material Used</i></p> <p style="text-align: right;">✓ Yes ___ No</p> <p>✓ Aluminum ___ Copper ___ Metal</p> <p style="text-align: right;">___ Tar Covered</p> <p style="text-align: right;">___ Disclaimed</p>		✓			
<p>5. Vent Pipes ___ 1 ✓ 2 ___ 3 ___ 4</p> <p style="text-align: right;">___ Aluminum ___ Copper</p> <p>___ Plastic ✓ Cast Iron ✓ Steel</p> <p style="text-align: right;">___ Unknown</p>		✓			
<p>6. Vent Pipe Flashing Utilized</p> <p style="text-align: right;">✓ Yes ___ No</p> <p>___ Tar Covered ___ None Noted</p> <p style="text-align: right;">___ Disclaimed</p>		✓

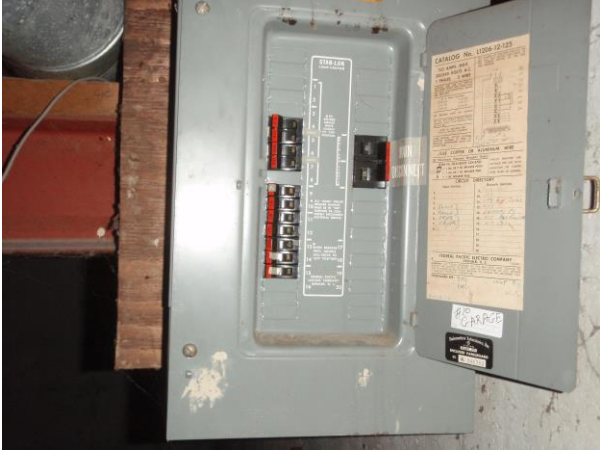
<input checked="" type="checkbox"/>
<p><i>Comments: This is a Federal Pacific Breaker box. An expert who investigated the potential hazards of Federal Pacific Electric panels stated under UL 489 test conditions, found that FPE panels fail to trip at a much higher rate than standard panels. When a breaker fails to trip, an extreme amount of power from the outside electrical supply surges into a home's panel and circuits. Once that happens, it cannot be stopped or shut off manually. Electricity will burn until it runs out of fuel or the wires melt. The panel could overheat and catch fire. Replacement is advised.</i></p>

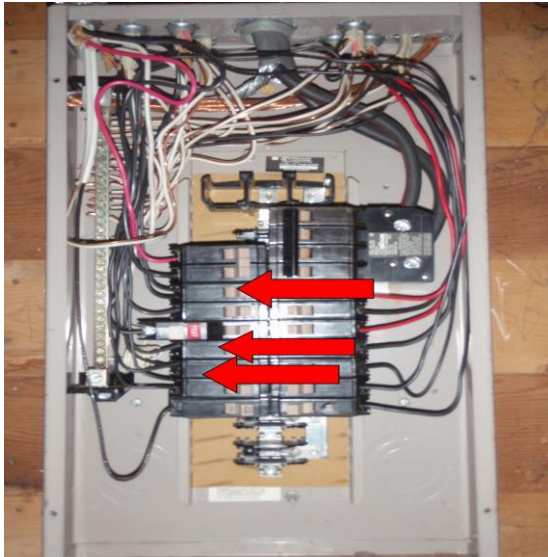
<p>Comments: <i>The above photograph shows several double taps in the electrical panel box. This is an unsafe arrangement. The wires in the breakers may come loose, or over heat the breaker itself. It is advised to consult a qualified electrician to evaluate this arrangement and suggest as to what repairs are needed. We will always recommend a qualified electrician to do all electrical repairs.</i></p>

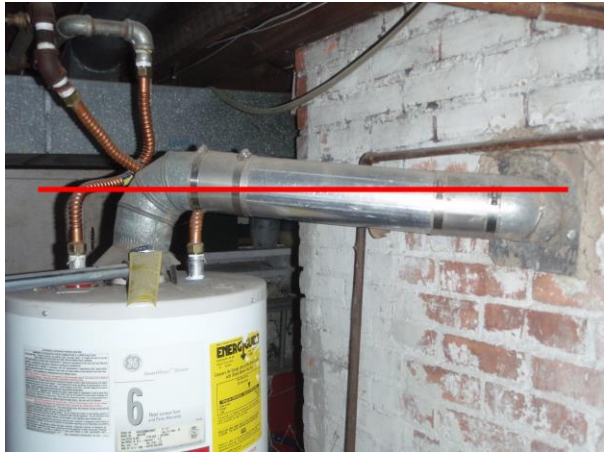
✓
<p>Comments: <i>Pictured above is the vent connector utilized at the how water heater. The red line indicates what would be level. Vent connectors should raise at a rate of 1\4" per foot. This will insure proper flow of burnt fuel. A negative grade as seen above could result in Carbon Monoxide issues. Reconfiguring this vent connector is advised.</i></p>

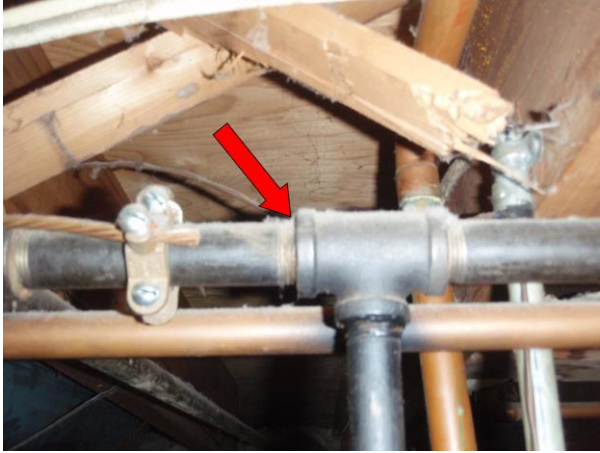
</div> <p><i>Comments: In the photograph above the arrow point to a union where a Natural Gas leak was detected. This is a safety concern. Natural Gas can contaminate the rooms' fresh air and possibly ignite at levels of 4% or higher. It is advised to have the leak repair now.</i></p>				✓

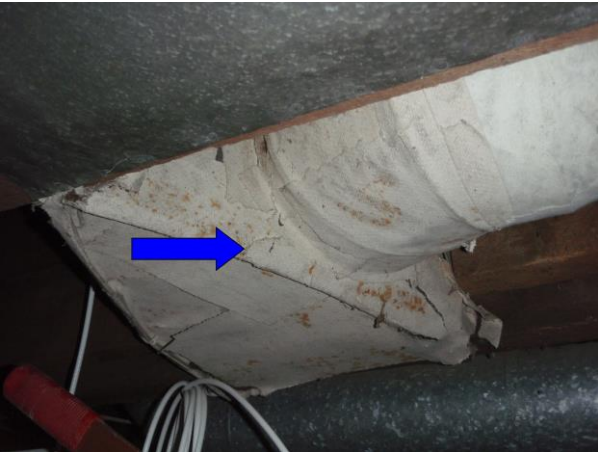
<p>15. Condition of Ducts, Returns, and Registers</p> <div style="text-align: center;">

</div> <p><i>Comments: The arrows above point to an insulating material that may contain asbestos. This is a health concern if particles of asbestos become air born. This is known as the asbestos being “friable”. It is recommended to consult a professional to determine if in fact this material here does in fact contain asbestos, and the correct means in which to remove or contain this material.</i></p>		✓

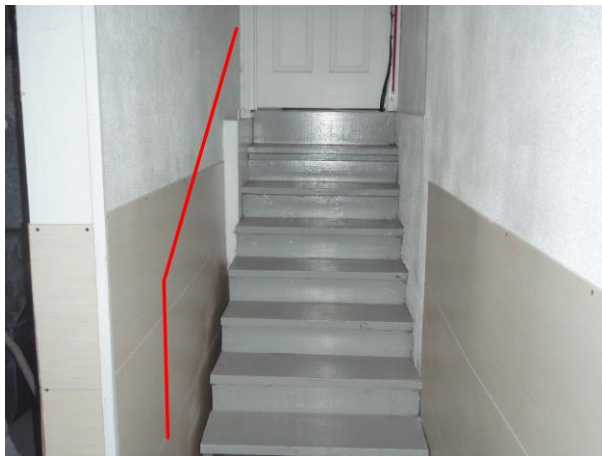
</div>				✓
<i>Comments: This is the stairway leading into the basement. The red lines indicate a missing handrail. Handrails are required on any stairway with three or more steps. Installing a handrail that will support the weight of a person falling, or able to support 200 pounds per foot is advised.</i>

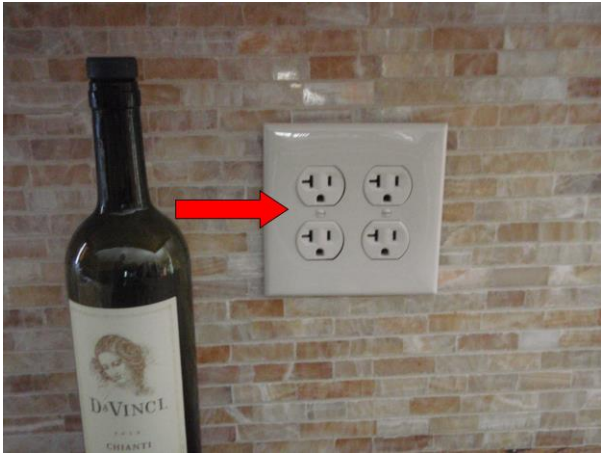
✓
Comments: <i>This outlet pictured above is of the three prong type. This is considered unsafe due to its close proximity to the kitchen sink and water supply. It is a National Standard to utilize GFCI in all kitchens. This outlet should be the GFCI type. Replacement is advised. All electrical work should be done by a qualified electrician.</i>

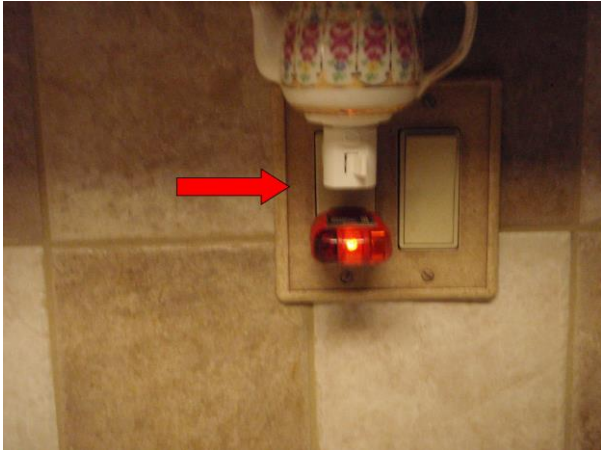
<p><i>Comments: Pictured above is the GFCI installed in the bathroom. Testing of this GFCI proved that it is wired "open ground". This GFCI will not work as intended. This is a safety concern due its close proximity to the bathroom water supply. It is recommended to have a qualified electrician make all necessary repairs.</i></p>				✓
<p>4. Bathroom Vent ✓ Yes ___ No ___ Window as Vent</p>	✓			
<p>5. Tub/Shower Wall Material Used ___ Plastic/Laminate ___ Granite/Stone ___ Hard Surface ✓ Ceramic Tile</p>	✓			
<p>6. Toilet</p>	✓			
<p>7. Walls/Ceilings/Floor Bathroom</p>	✓			
<p>8. Function of Representative Number Of Doors and Windows</p>	✓
